WGSL, CQA Report Documenting Repairs to the Final Section of Cell E6 Liner

Subject: Liner Damage Assessment, Repair, and Construction Quality Assurance Report
for Cell E6 Sideslope, Waimanalo Gulch Sanitary Landfill, Kapolei, HI

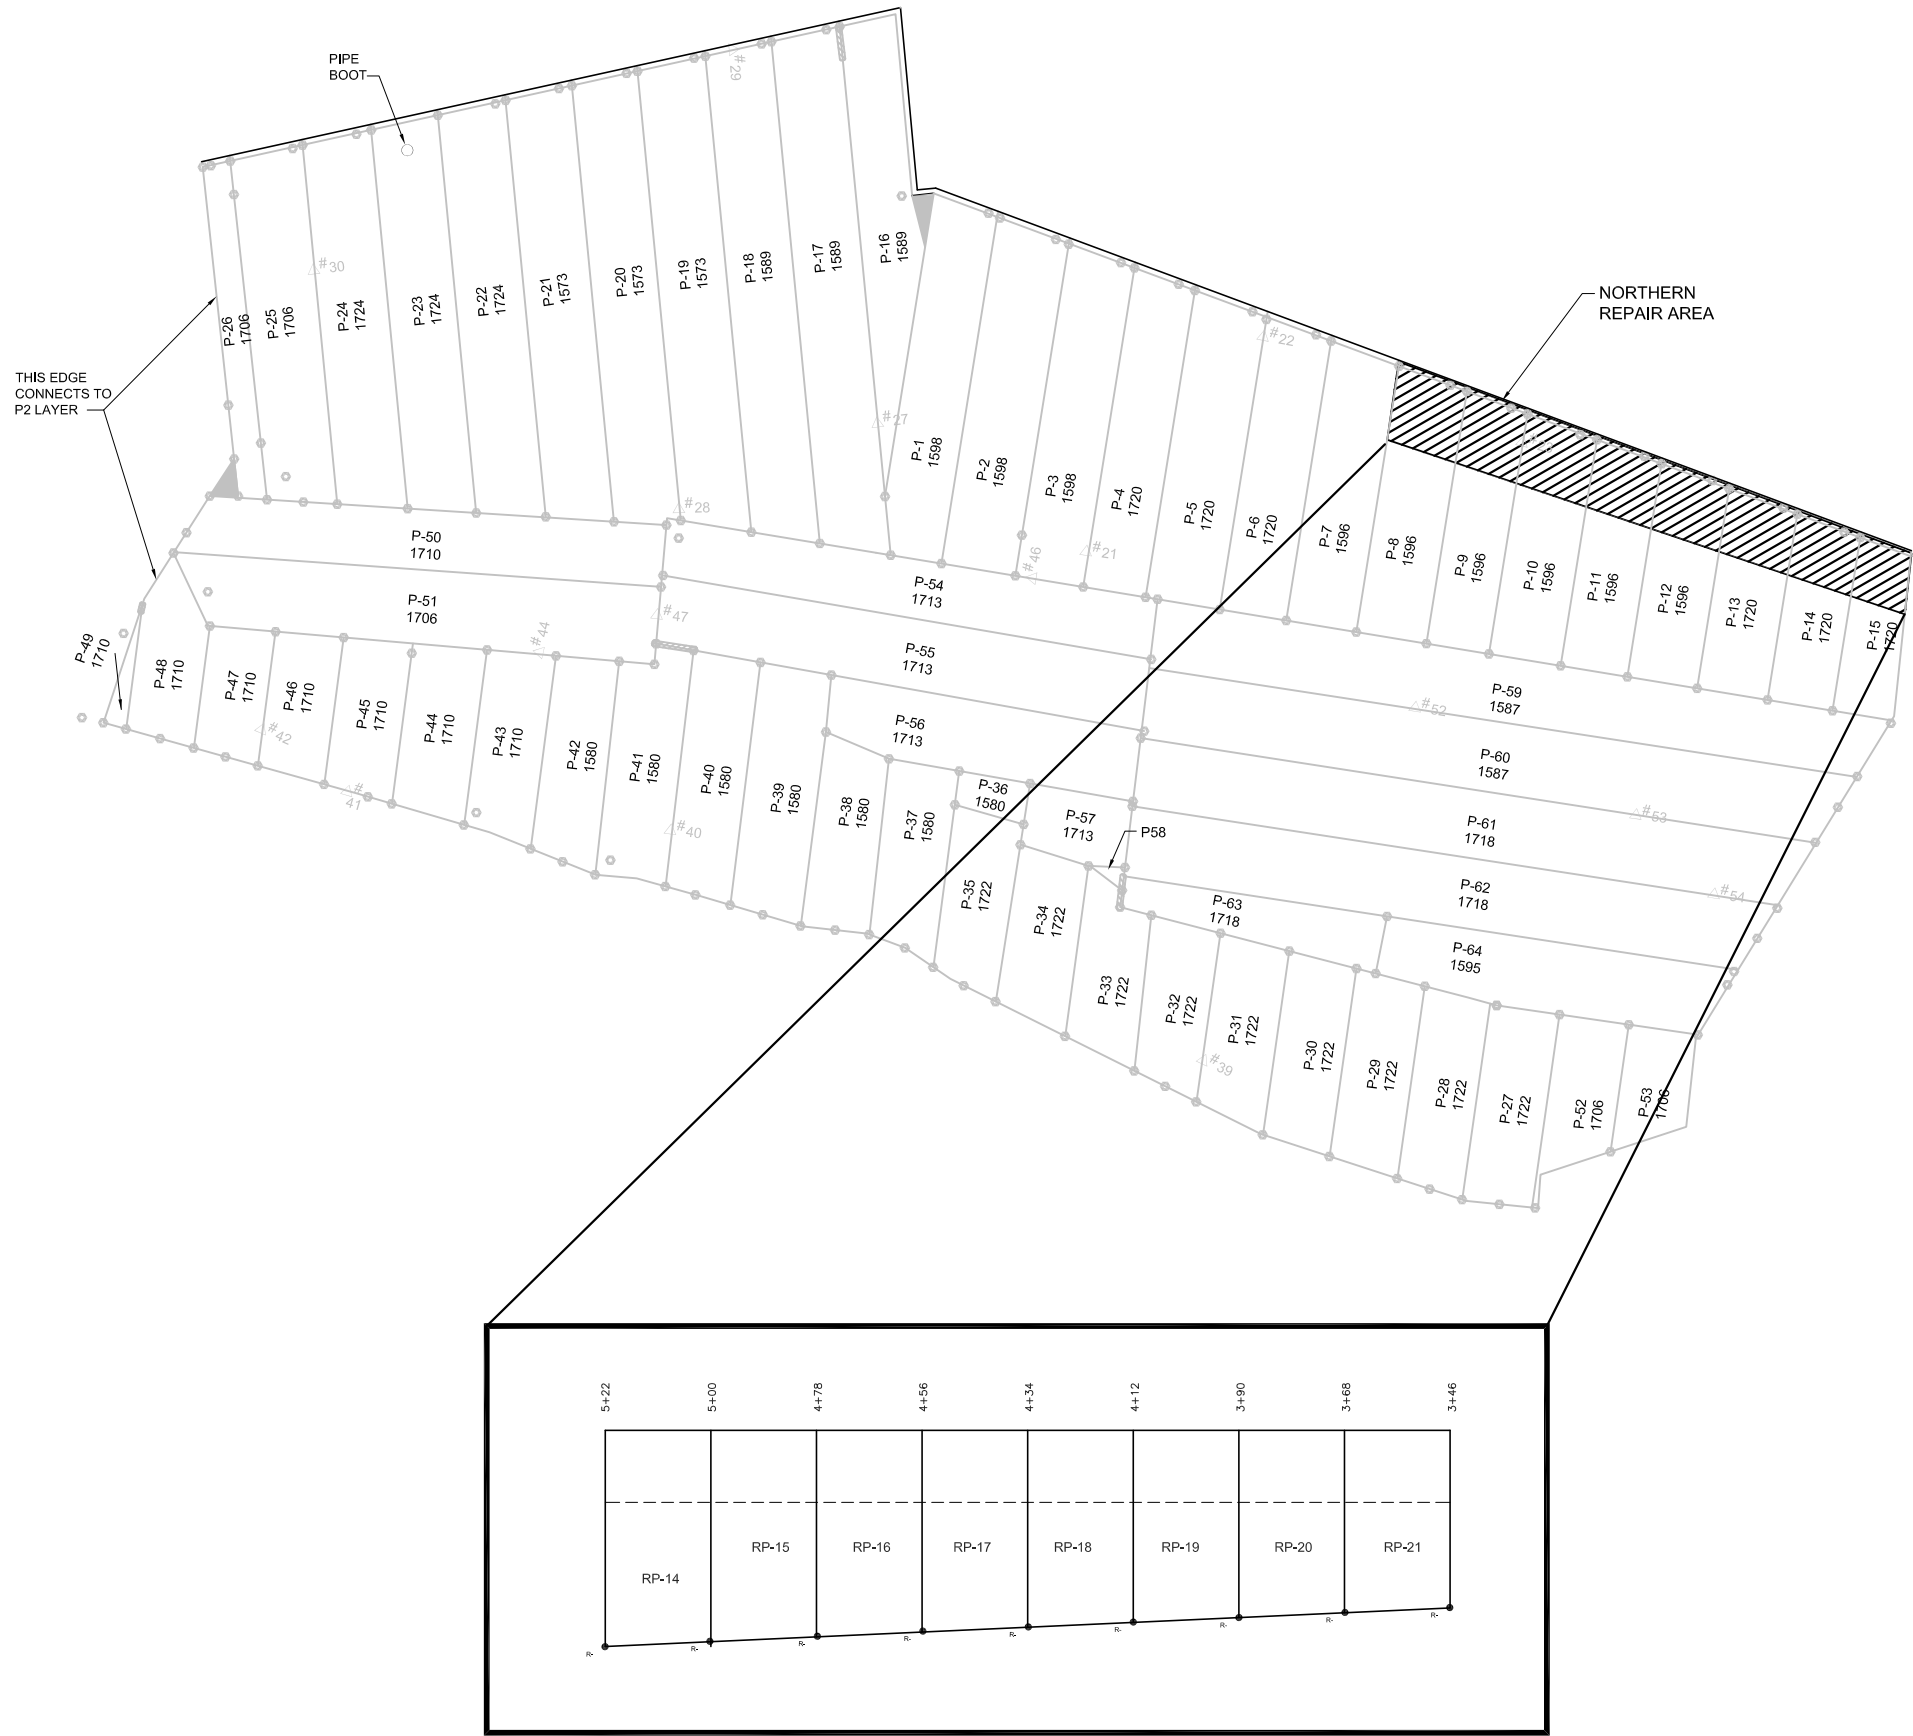
Figure 3
Northern Repair Area,
60-mil Repair Locations

Hydrated or otherwise damaged GCL was replaced in the designated repair areas beneath the 60-mil HDPE geomembrane as shown on Figure 2 and Figure 3. The GCL was deployed in a manner not to entrap stones or other loose soil under the material. All adjacent panels of new GCL were overlapped a minimum of 18 inches and bentonite was applied at a rate of 1/4 pound per ft of seam. As it was necessary to remove hydrated GCL on the sideslopes, horizontal seams on the sideslope were required to complete the repairs. Request for Information (RFI) Number (No.) 26, approved the use of horizontal seams on slopes steeper than 10 horizontal to 1 vertical and required an overlap of 5 ft and gluing with 3M Super 77 glue. A copy of the RFI is included in Attachment 8. Horizontal seams installed during the repairs were completed in accordance with RFI No. 26.

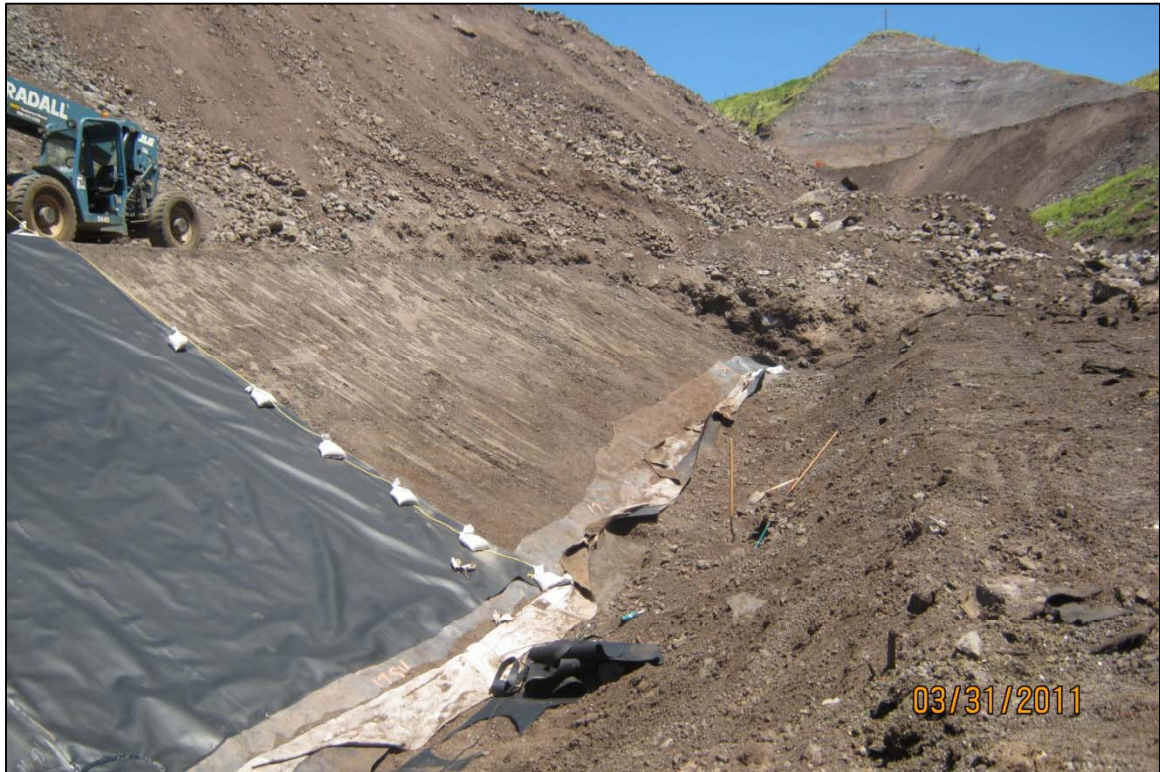
Photo 3: Northern portion of the northern repair area prior to deployment of 40-mil geomembrane.

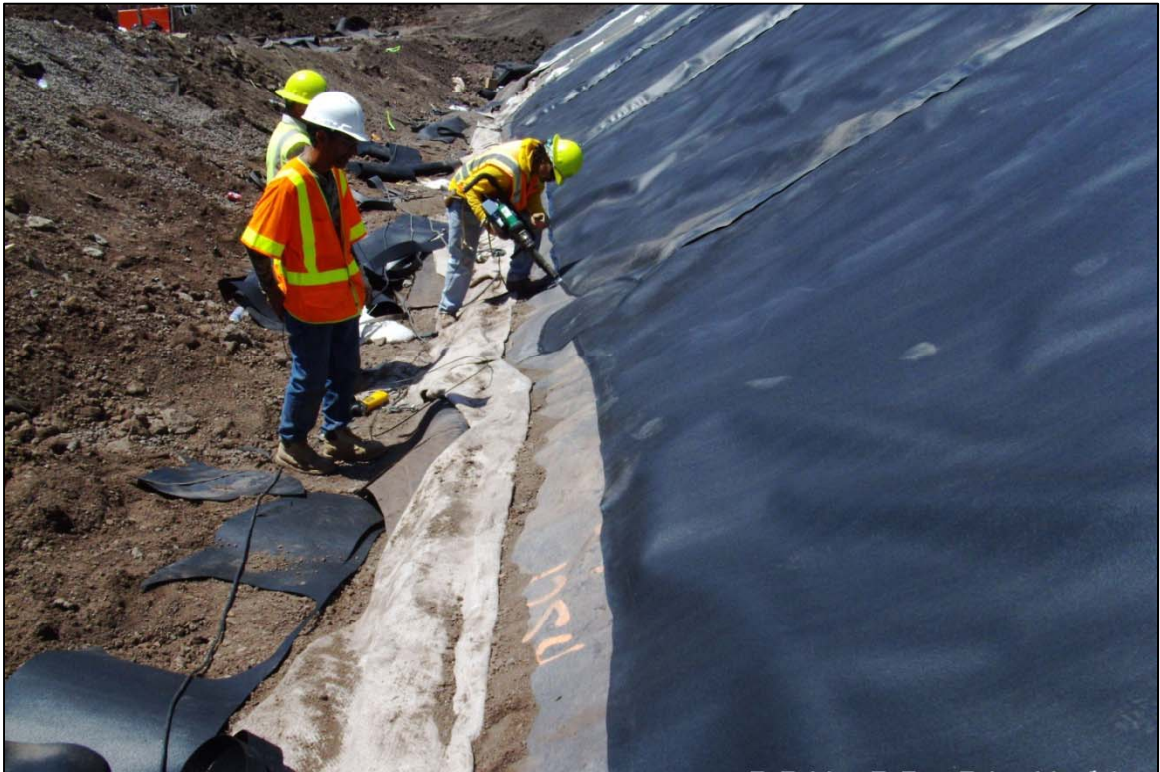
Photo 5: Extrusion welding the 40-mil geomembrane repair panel tie-in to the existing E6 liner system.

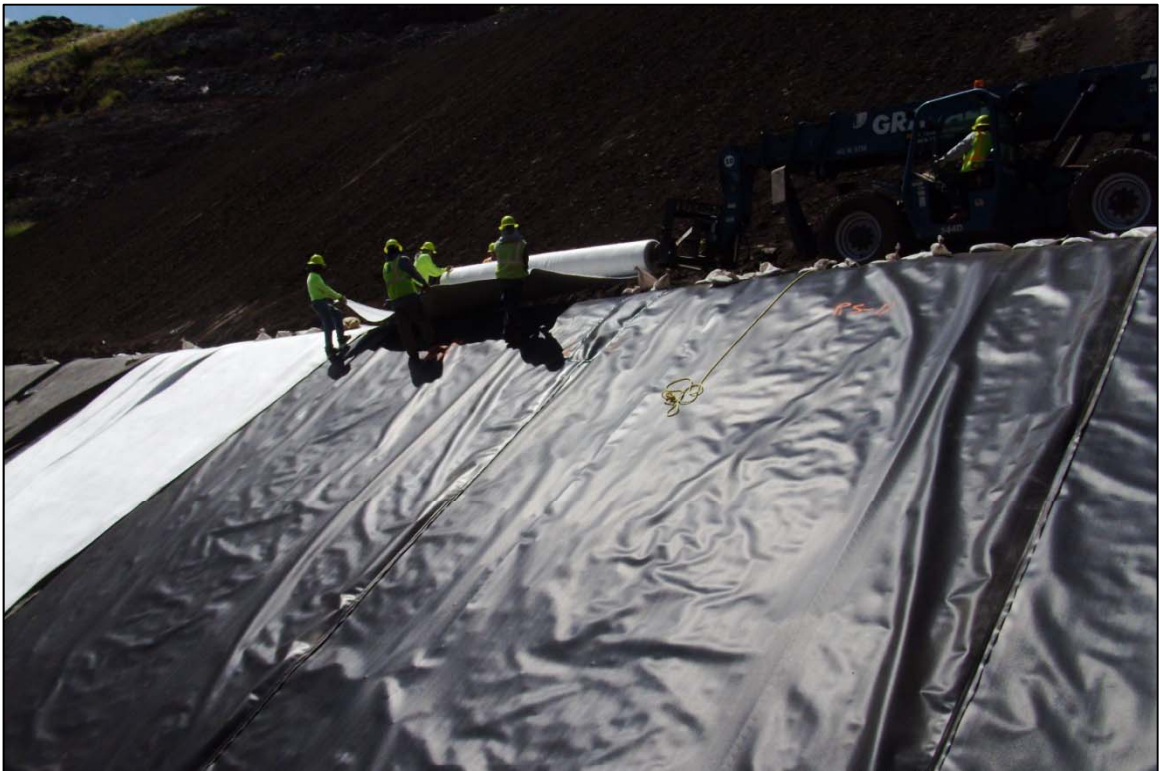
Photo 6: Deploying GCL over the 40-mil geomembrane repair panels on the northern portion of the northern repair area.
